Building Condition Assessment Report

Asset	C4a - Boys Industrial School - Valleyview Lodge	
Address	Riverview Lands, 2601 Lougheed Highway, Coquitlam, BC. V5C 4J2	
Construction Year	1922.	
Size (Gross Floor Area)	7,815	Sq.Ft.
Asset Type	RV_Assisted - Senior Living with Brick Veneer on Block / Bearing Wall, Valleyview and Cottages 1, 2 & 3	
Floors Above Ground	2	
Report Date	September 2013

Summary Results of Assessment: C4a - Boys Industrial School - Valleyview Lodge

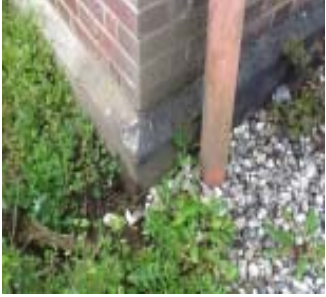
A10 Foundations

<u>Component</u>	1	<u>Overall Condition</u>	Critical

<u>Replacement Value</u>	\$220,000		
<u>What & Where</u>	Concrete and brick foundations with brick interior partition and load bearing walls.		
<u>Commentary (Condition ...)</u>	Seismic upgrade required (consultant assessment required to confirm scope and more accurate cost)		
 <u>Action</u>	 1.		
<u>Action Type</u>	Replacement		
<u>Action Cost</u>	\$220,000		
<u>Action Year</u>	2014.		
<u>Brief Description</u>	Replace and repair existing brick foundations and interlocking clay tile load bearing walls.		
 <u>Commentary</u>	Recommend a Consultants seismic assessment to further determine scope and replacement cost if building is to remain.
