Building Condition Assessment Report

Asset	C3b - Holly Drive Cottage 112	
Address	Riverview Lands, 2601 Lougheed Highway, Coquitlam, BC. V5C 4J2	
Construction Year	1922.	
Size (Gross Floor Area)	1,720	Sq.Ft.
Asset Type	RV_Cottage 107 etc., 2 Story Vinyl Siding & 15% Brick Veneer / Wood Frame	
Floors Above Ground	2	
Report Date	September 2013

Summary Results of Assessment: C3b - Holly Drive Cottage 112

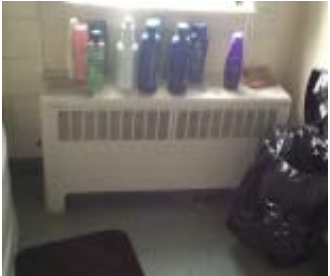
<u>Replacement Value</u>	\$5,000		
<u>What & Where</u>	Cast iron hot water radiators and/or fin tube heat registers throughout. Decommissioned wood burning fireplace.		
<u>Commentary (Condition ...)</u>	Cast iron radiators and/or fin tube heaters seem to be original.		
 <u>Action</u>			
<u>Action Type</u>	1.		
<u>Action Cost</u>	Replacement		
<u>Action Year</u>	\$5,000		
<u>Brief Description</u>	2020.		
<u>Commentary</u>
